Letter of Transmittal

Date	17 January 2008
File Number	26708
From	Susan Hoertt, R.S., CPEA
То	U.S. EPA Region V Emergency Response Branch Command Post 919 Keowee Street Dayton, OH 45404
Attention	Steve Renninger, On-Scene Coordinator
Copy to	Randy Kirkland, Weston Solutions
Subject	Delphi Home Avenue Phase I SSD System Photos
Copies	Date Description
1	17 January CD 2008
Transmitted via	☐ First class mail ☐ Overnight express ☒ Hand delivery ☐ Other

Attachment 4 Delphi VOC Plume Site - Uninhabitable Structures

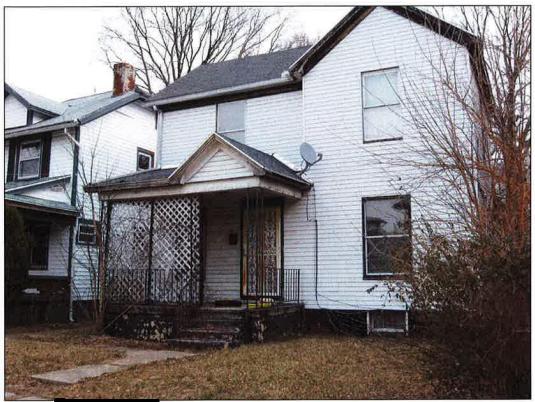
Photo 1 Ex. 6 P... Names, Address... — front (west side) of property.

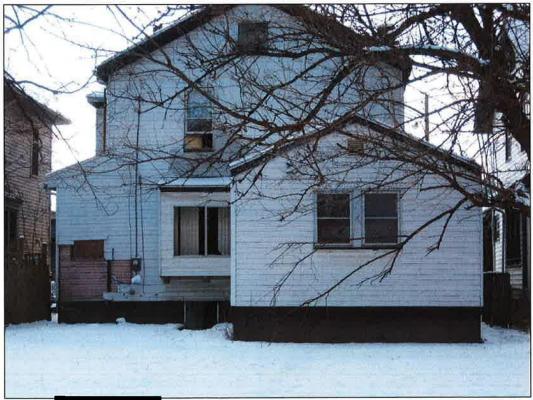
Photo 2: Ex. 6 P... Names, Address... – rear (east side) of property. Note unsecured property with broken windows and doors ajar.

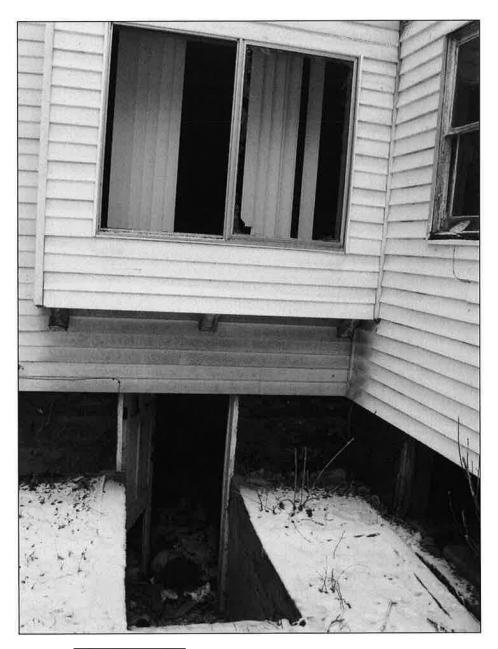
Photo 3: Ex. 6 P... Names, Addresses... rear (east side) of property. Note unsecured property with windows broken and door ajar.

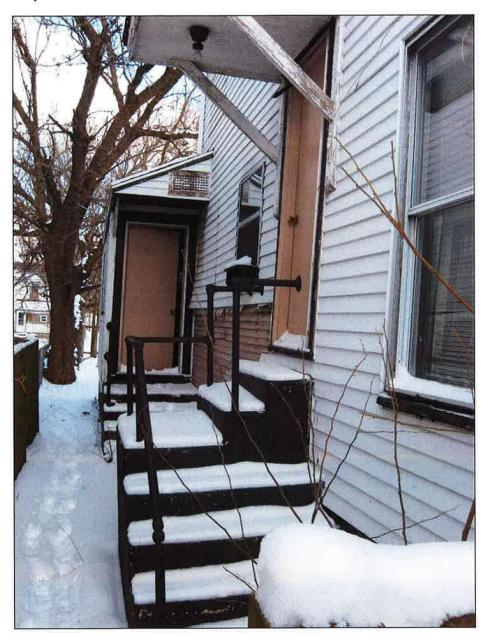
Photo 4: Ex. 6 P... Names, Addr... – north side of property. Note unsecured property with door ajar.

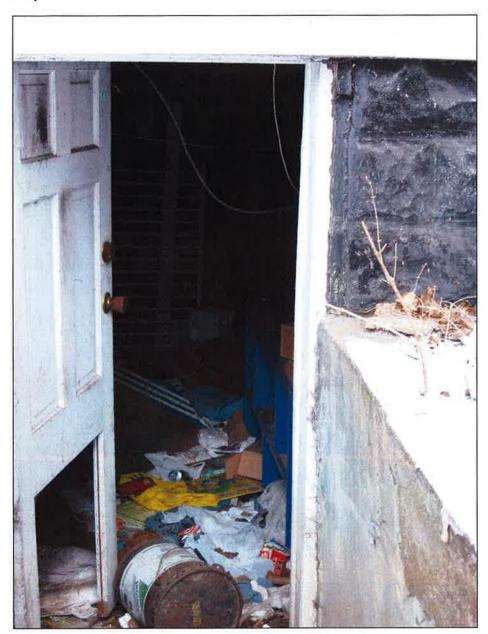
Photo 5: Ex. 6 P... Names, Addre... – rear (east side) of property. Note unsecured property with door ajar.

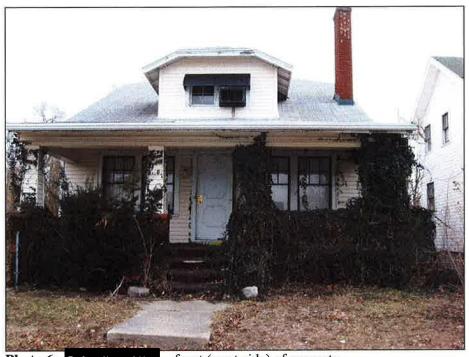
Photo 6: Ex. 6 P... Names, Addr... – front (west side) of property.

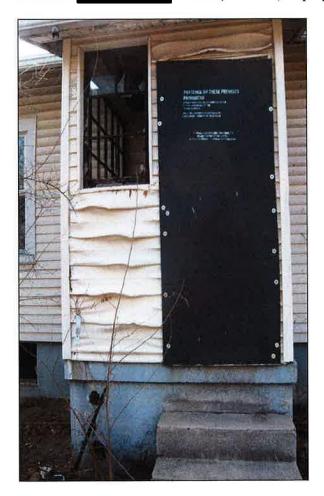
Photo 7: Ex. 6 P... Names, Addr... – back (east side) of property. Note broken window, evidence of possible fire damage, and City of Dayton Department of Building Services boarding and notice, "Presence on these Premises Prohibited."

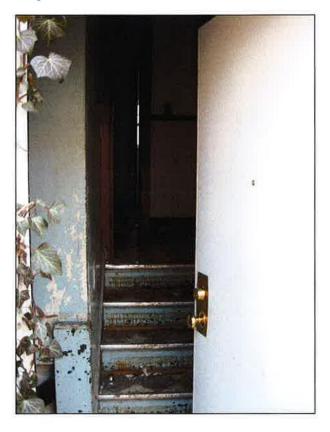
Photo 8: Ex. 6 P... Names, Addresses... north side of property. Note unsecured property with door ajar.

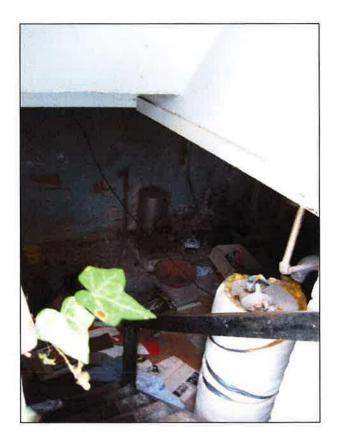
Photo 9: Ex. 6 P... Names, Addre... — north side of property. Note unsecured property with door ajar.

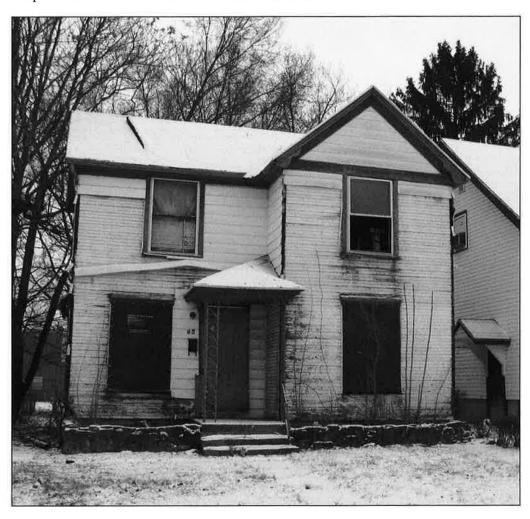
Photo 10 Ex. 6 P... Names, Addre... – front (west side) of property. Note broken windows and City of Dayton Department of Building Services boarding and notice, "Presence on these Premises Prohibited."

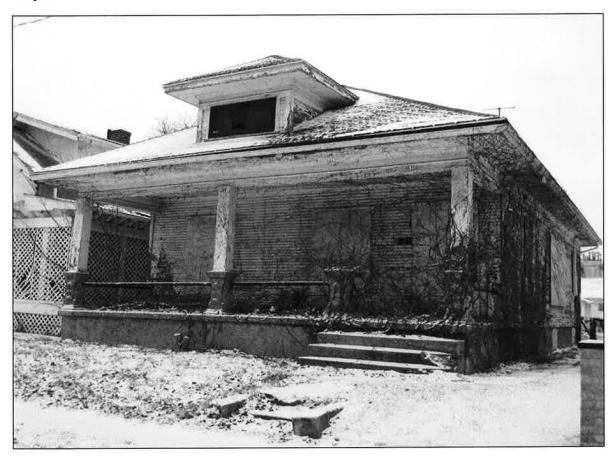
Photo 11: Ex. 6 P... Names, Ad... – front (east side) of property. Note City of Dayton Department of Building Services boarding.

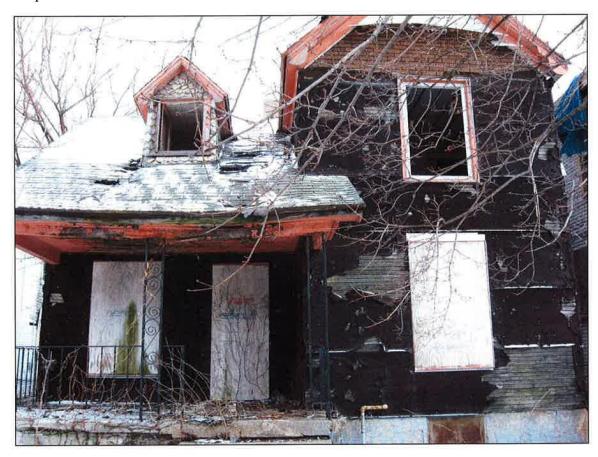
Photo 12 Ex. 6 P... Names, Addr... – front (west side) of property. Note broken windows, apparent structural damage, City of Dayton Department of Building Services boarding and notice, "Public Nuisance, No Occupancy, No Trespassing."

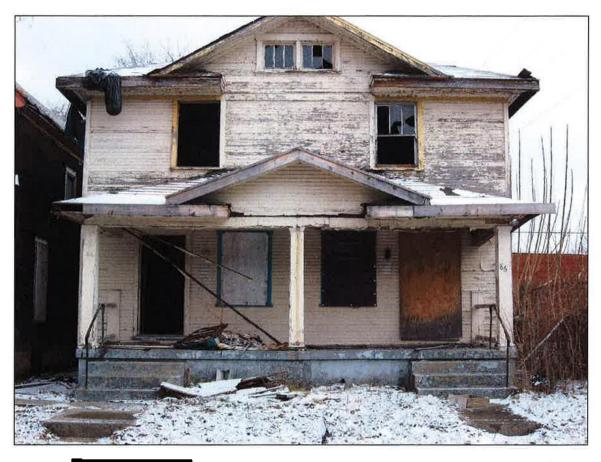
Photo 13 Ex. 6 P... Names, Addresses a... – front (west side) of property. Note unsecured property with broken windows, missing door, apparent structural damage, and City of Dayton Department of Building Services boarding and notice, "Presence on these Premises Prohibited."

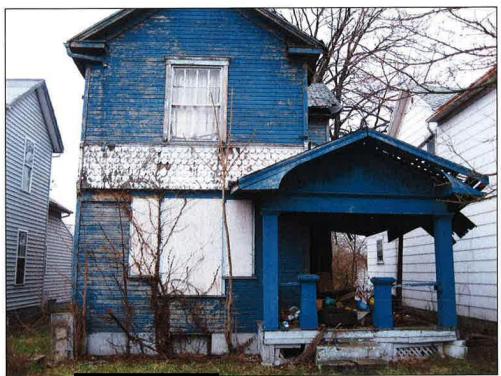
Photo 14: Ex. 6 P... Names, Addresses and phon... – front (west side) of property. Note unsecured property with broken windows, missing door and accumulation of material blocking entrance.

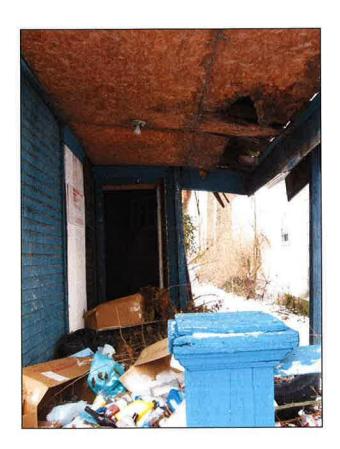
Photo 15: Ex. 6 P... Names, Addresses and ph...

- front (southwest side) of property,
Note missing door, window ajar,
apparent structural damage, and
City of Dayton Department of
Building Services boarding and
notice.

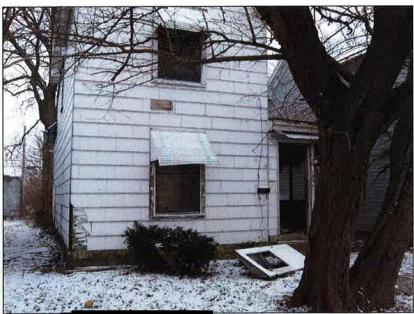
Photo 16: Ex. 6 P... Names, Addresses and phone... – front (west side) of property. Note unsecured property.

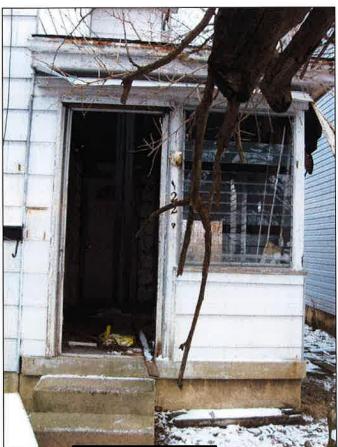
Photo 17: Ex. 6 P... Names, Addresses and pho... – front (southwest side) of property. Note unsecured property and possible structural damage.
